TECHNICAL REPORT NO. 6-570 -

DURABILITY AND BEHAVIOR OF PRESTRESSED CONCRETE BEAMS

LABORATORY TESTS OF WEATHERED PRETENSIONED BEAMS

June 1976

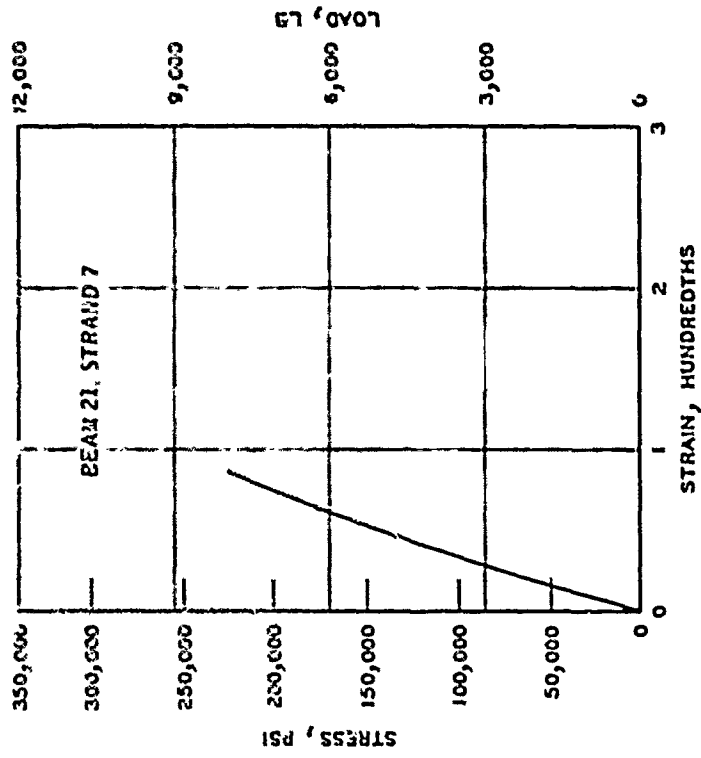
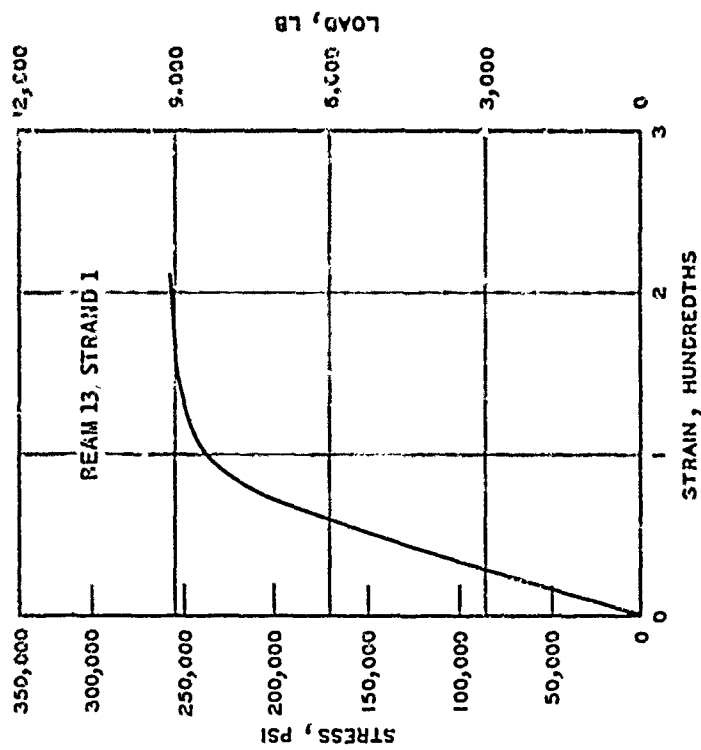
STRESS-STRAIN CURVES

A typical stress-strain curve for each beam is presented in Plate 1.
